TEST REPORT

Report Number: 1724-12001

Sample Description: ABS plastic shower tile drain

Scope of Testing: The purpose of the testing was to determine if the samples tested of the ABS plastic shower tile drain met the applicable requirements of ASME A112.18.2-2011/CSA B125.2-11, entitled, "Plumbing Waste Fittings".

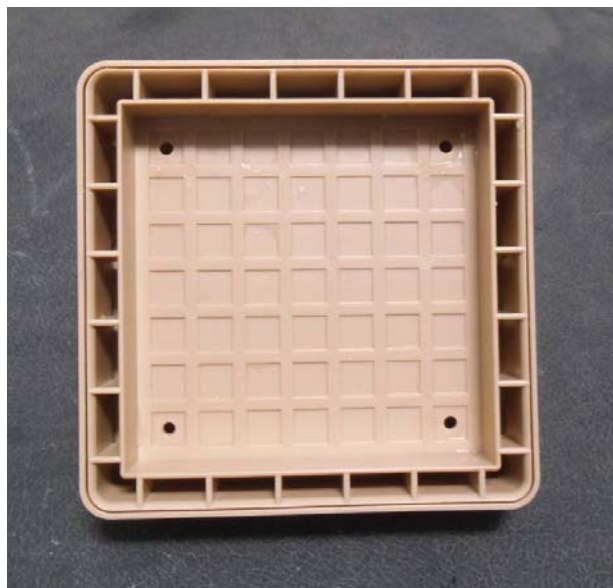
Model TD101 (Top View)

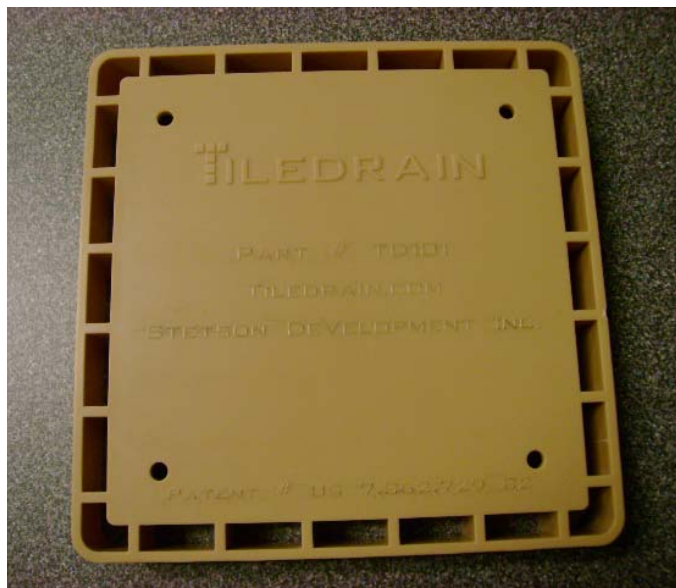
Markings underneath Drain Tray

The shower drain was permanently marked with the manufacturer’s name “Stetson Development Inc.” underneath the drain tray and the marking could be visible after installation.

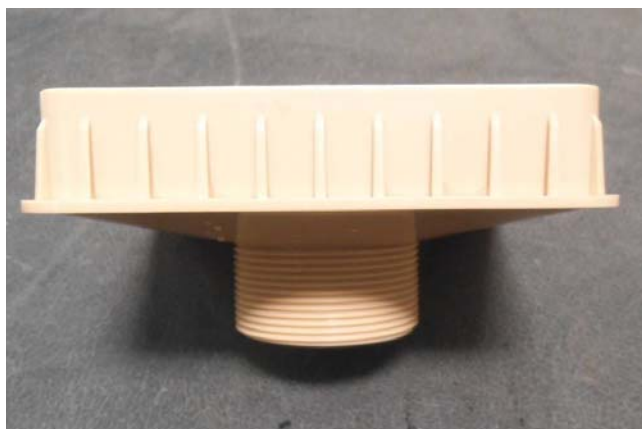
Model TD101 (Side View)

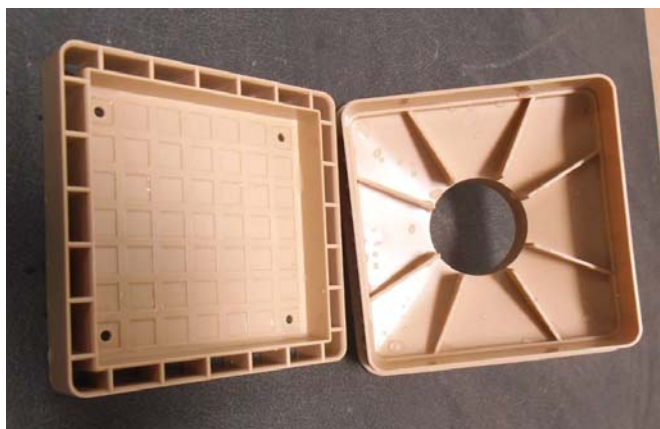
Model TD101 (Drain Tray + Body)

Finding: The shower drain strainer (tile drain tray) did not crack and the deflection was not more than 3% of the largest transverse dimension with the load in place. The measured deflection was 1.45%.
